Managing Invasive Aquatic Plants

Note in response to the request from the UN Resident Coordinator’s Office in Côte d'Ivoire, focussing on the Yamoussoukro lakes

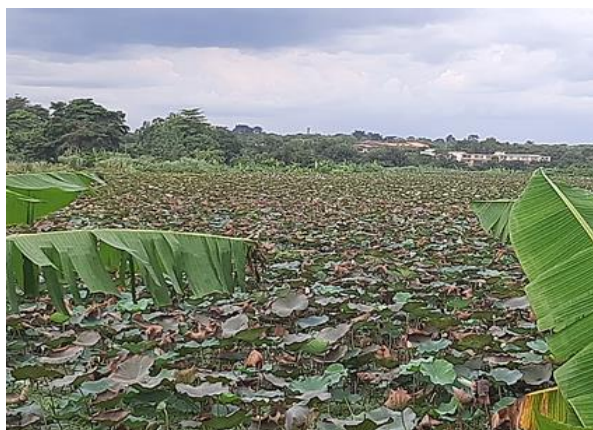
- Weed coverage ranges from partial (5 lakes) to total / almost total (9 lakes), with average height of biomass estimated at 0.5m. Shorelines of lakes mostly completely overgrown.
- Type of weeds: sacred lotus (*nelumbo nucifera*³, roots in bottom) (all lakes), water hyacinth (2 lakes), tall grasses / reeds / shrubs. Banana plants on 4 lakes.
- Weeds rooted to the bottom (likely making them more difficult to remove mechanically)
- Pollution: sewage (in most lakes) and macro waste (in some)
- High number of crocodiles and caimans in lakes 1-4 (“thousands”)
- Damaged connecting culverts and concrete slabs around many of the lakes
- Siltation
- Cultivation of market gardens by local residents on lakes 8 and 9.
